CONNECT-EZ LOAD TEST REPORT

Phase I

Series "V" - 12 x 12

University of Cincinnati

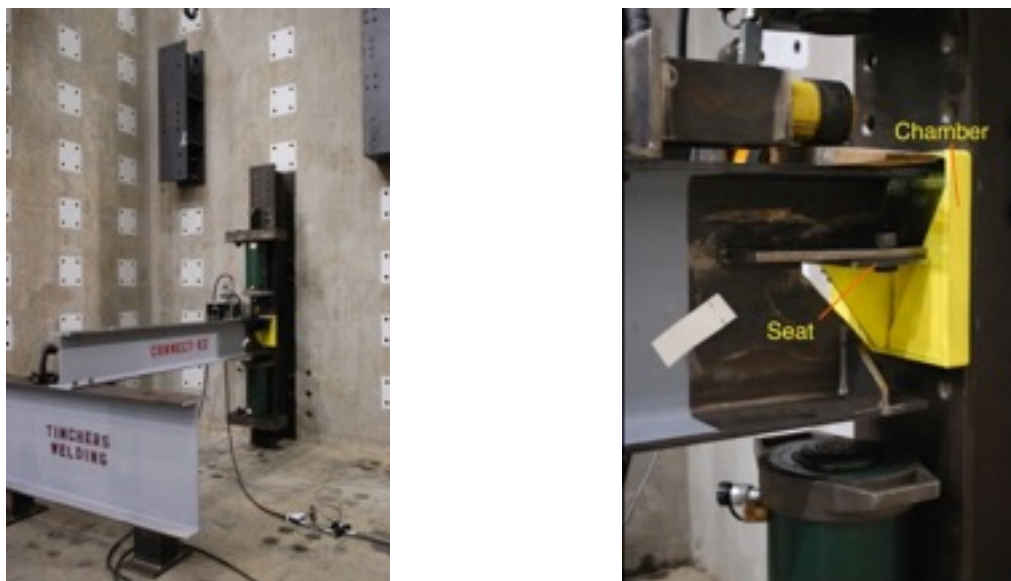
Figure 1 Test Setup

In order to understand the behavior and capacity of CONNECT-EZ devices, a series of load tests was conducted. The focus of this phase of testing was on the CONNECT-EZ (C-EZ) “V” 12x12 devices. The test apparatus (Figure 1) allowed application of lateral load simultaneously with gravity, pullout, or uplift loads that were transferred from the C-EZ bearing-seat to the C-EZ chamber and from the C-EZ chamber to four ¾-inch diameter steel studs. The tests were performed at the University of Cincinnati Large Scale Test Facility (UCLSTF).

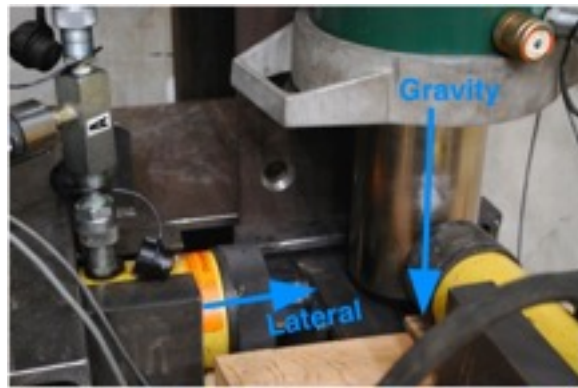
Figure 2 Hydraulic Jacks

The load combinations were applied according to the protocol shown in Table 1. A pair of hydraulic jacks, shown in Figure 2, was used for the various loading combinations. The locations of various hydraulic jacks are shown in Figure 3. Calibrated pressure transducers were used to electronically measure and record the applied loads.

(a) Lateral + Pullout

(b) Lateral + Gravity

(c) Lateral + Uplift

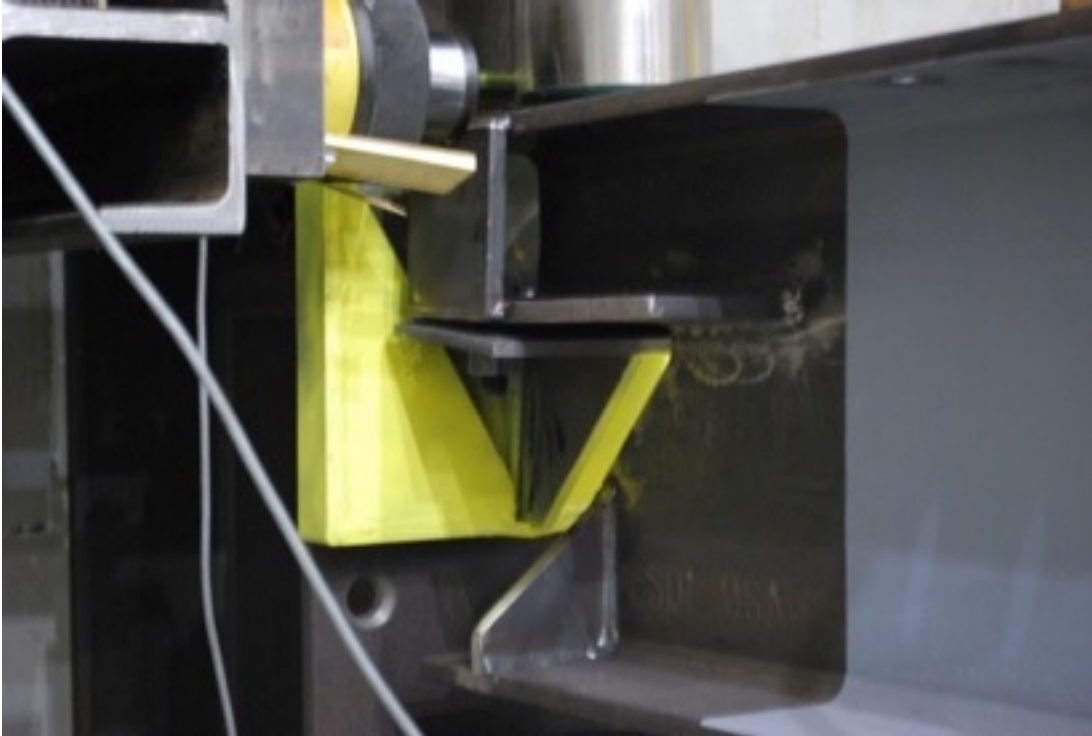
Figure 6 Failure of Specimen

In this specimen, the back edge of the seat was welded (1/4 inch x 6 inch fillet) to the inside face of the chamber. The test results are summarized in Table 4. After applying 76 kips of gravity load, the gusset plate under the seat began to yield, as shown in Figure 5. At 97.2 kips, the weld between the seat and the chamber began to fracture after noticeable bending of the seat (see Figure 6), and testing was stopped. After weld fracture, the connection was still able to resist 63.5 kips of gravity load, which corresponds to a safety factor of 2.12, and 2.3 kips of lateral load. Considering the excessive bending of the seat and residual capacity, the failure mode is classified as ductile. The failure load corresponds to a safety factor of 3.24.

(a) Prior to Weld Fracture

(b) Weld Fracture
